Weston Solutions of Michigan, Inc.  
Suite R  
360 E. Maple Road  
Troy, MI 48063  
248-658-5000 • Fax 248-658-5001  
www.westonsolutions.com

**Subject: Durable Coatings Site Removal Action  
Northville Township, Wayne County, Michigan  
Technical Direction Document No.: S05-0001-1109-002  
Document Control No.: 1592-2A-AUQD  
Work Order No.: 20405.012.001.1592.00**

This letter report discusses the Site description and history, background, removal action activities, the effectiveness of the removal action, and conclusions.

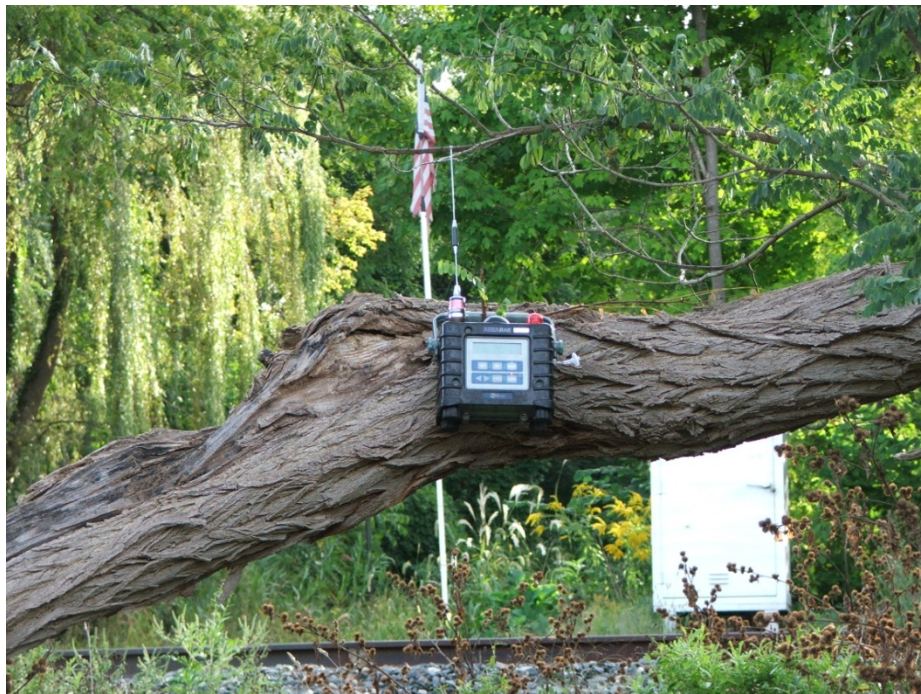
**Photograph No.:** 4

**Subject:** Perimeter air monitoring with AreaRAE unit

WESTON START conducted Site perimeter and breathing zone air monitoring during times of removal activities within the exclusion zone as defined in the site-specific HASP. A MultiRAE Plus photoionization detector was used to monitor air quality for volatile organic compounds (VOC), carbon monoxide (CO), hydrogen sulfide (H<sub>2</sub>S), lower explosive limit (LEL), and percent oxygen (% O<sub>2</sub>). An additional four AreaRAE units, also monitoring for VOC, CO, H<sub>2</sub>S, LEL, and % O<sub>2</sub>, were deployed throughout the Site. Common AreaRAE deployment locations, over the duration of the project, included within the CRZ, the exclusion zone, and along the northeast and southeast Site perimeter. In addition, two DataRAM units were used to monitor the work zones air quality for dust particulates. Each air monitoring instrument was calibrated daily prior to use in the field, and its calibration readings recorded in the Site logbook.

WESTON START conducted air monitoring, outside the exclusion zone, in Level D PPE. Dust particulate readings ranged from approximately 6.7 to 274.1 micrograms per cubic meter (µg/m<sup>3</sup>) during the removal action activities. Daily peak measures were never sustained for a long period of time and all measures were below the particulate action level criteria of 2.5 milligrams per cubic meter (mg/m<sup>3</sup>), determined by half of the respiratory permissible exposure limit of 5 mg/m<sup>3</sup> established by the Occupational Safety & Health Administration. No CO, H<sub>2</sub>S, LEL, or % O<sub>2</sub> readings exceeded action levels during the removal action. Elevated measures for these gases were at times encountered with the AreaRAE units during the removal action, but were quickly dismissed after cross-checking the measurements with the MultiRae unit. High humidity conditions within the Site building and sensor drift were likely causes for these erroneous measures. Maximum sustained VOC measures of 22.0 parts per million were encountered on October 10, 2011, during the transfer and consolidation of flammable liquids in bulk containers for disposal. In response, a temporary stop-work was issued by the response manager until

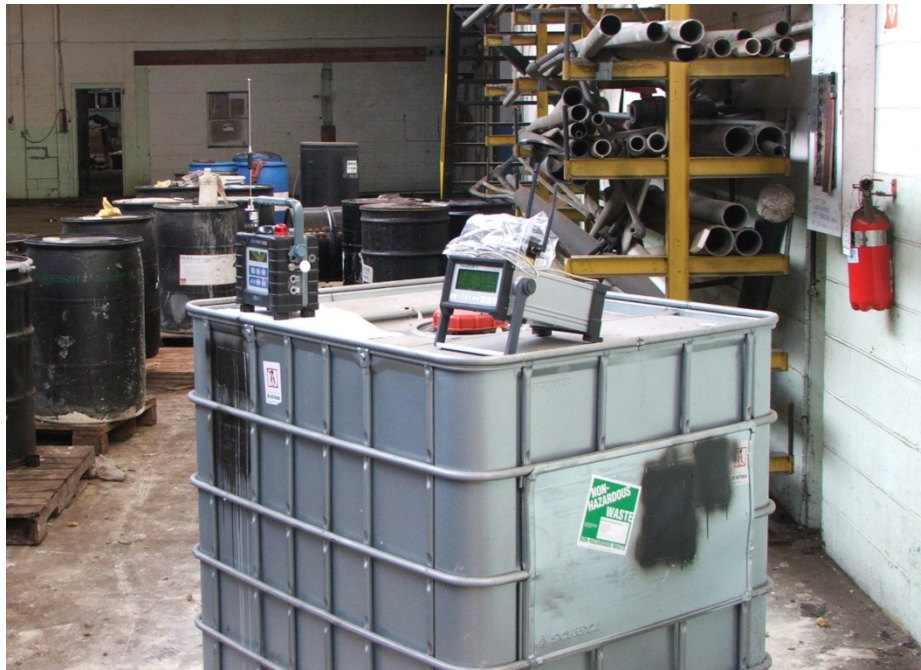
**Photograph No.:** 5

**Subject:** AreaRAE and DataRAM air monitoring in Room 7

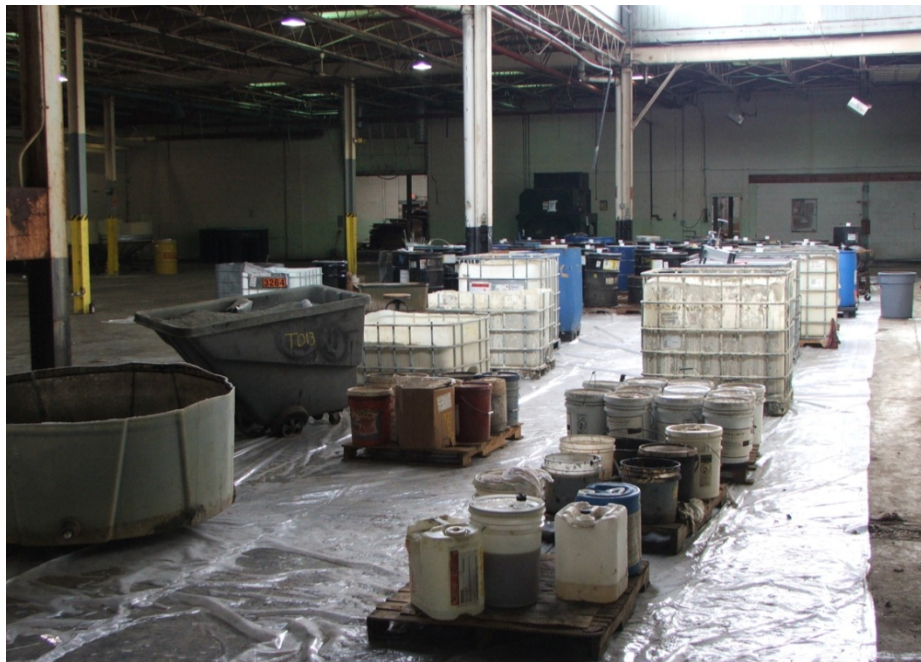
**Photograph No.:** 6

**Subject:** Site building Room 7, container staging area

Containerized waste at Durable Coatings was situated in various locations throughout the Site building. Due to its size, ambient lighting, and ventilation; Room 7 was chosen as the location for staging all drums and containers to be sampled, consolidated, and prepped for disposal. The staging area was set up with plastic sheeting on the floor and pallets for storing the collected containers. The containers were moved to the staging area by hand or by use of a tracked skid-steer, and arranged in a way to allow easy access to sampling at a later date. Container sizes ranged from less than one-gallon to a 13,500 gallon AST. Waste containers also ranged from full to empty containers, labeled to unlabeled unknowns, and in good to poor condition.

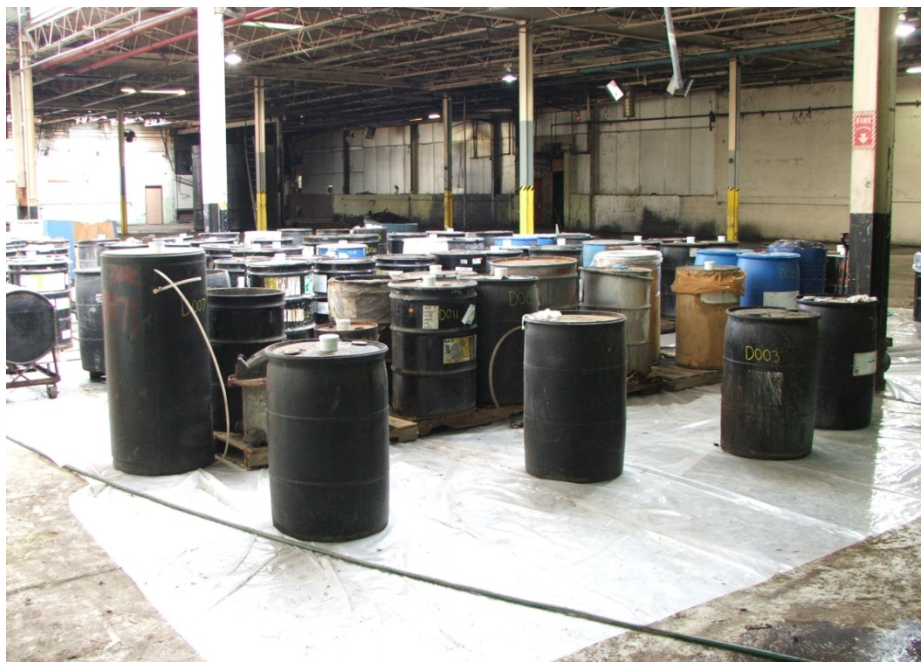
**Site:** Durable Coatings  
**Photograph No.:** 7  
**Direction:** Northeast  
**Subject:** Site building Room 7, container staging area

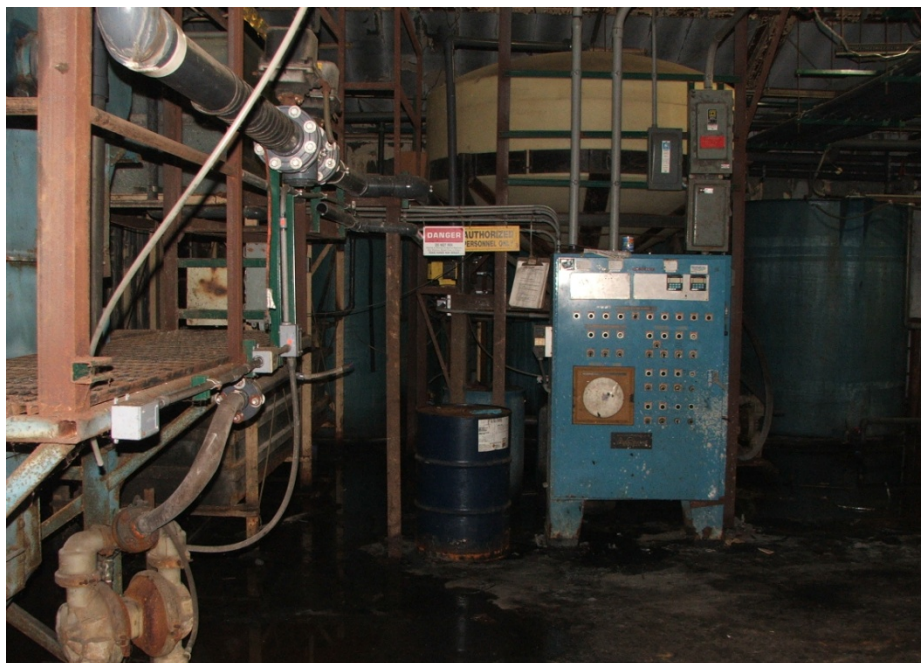
**Site:** Durable Coatings  
**Photograph No.:** 8  
**Direction:** East  
**Subject:** Waste water treatment system

At the time of mobilization, the Durable Coatings facility had a system in place to treat waste waters produced when operations occurred at the Site. The WWTS was located within Room 3

and was comprised of various ASTs, vats, and associated piping, some of which contained wastes, and support structures. As part of the removal action, the WWTS was dismantled to provide access to the vats and ASTs for removal and to render the system unusable. In addition, any remaining containers on Site, including drums, totes, and ASTs, were crushed or cut up into pieces, loaded into roll-off dumpsters, and disposed of as non-hazardous RCRA empty containers and construction debris.

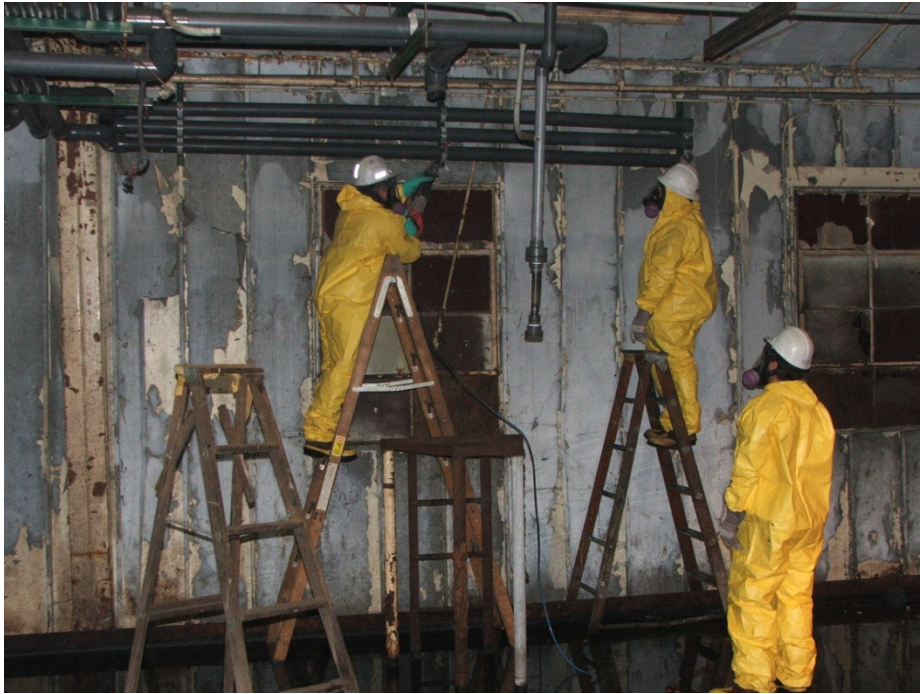
**Photograph No.:** 9

**Subject:** Dismantling of the waste water treatment system

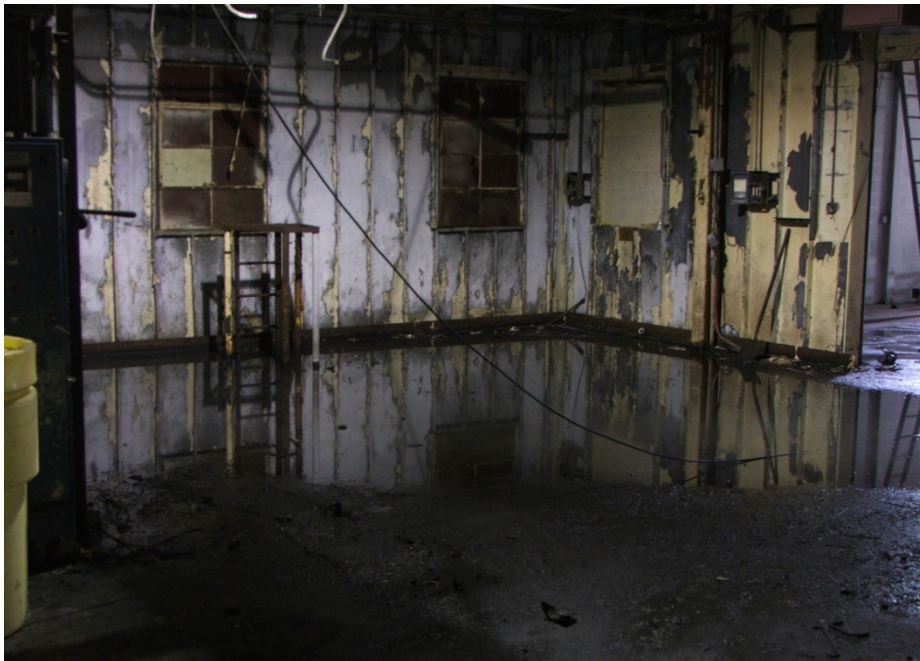
**Photograph No.:** 10

**Subject:** Waste water treatment system removal complete

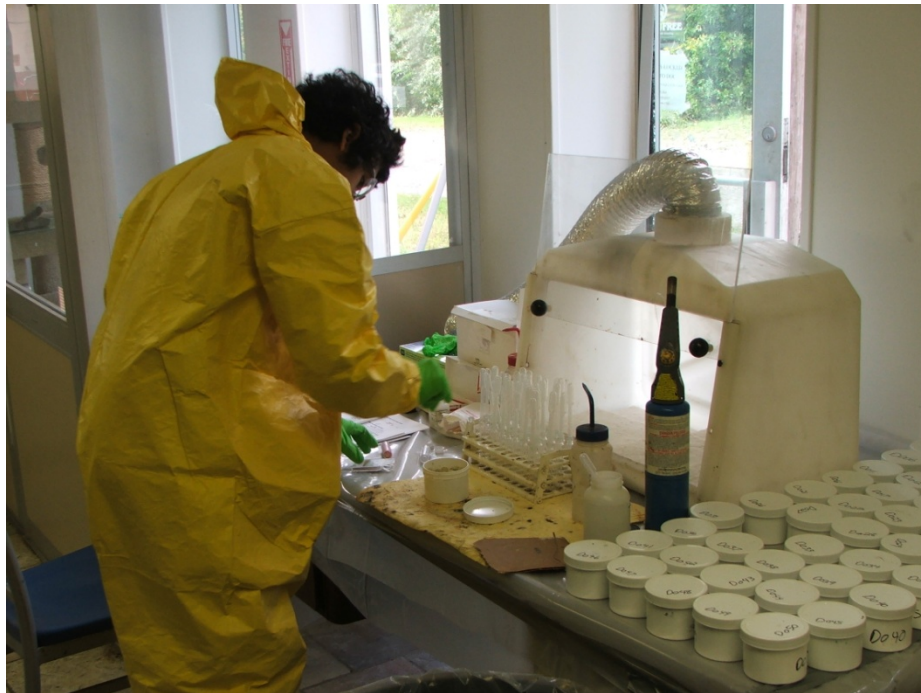
**Photograph No.:** 11

**Subject:** Hazardous Categorization (HazCat) of unknown waste

Waste sampling of unknown solid and liquid wastes began on September 22, 2011. Samples were collected by EERS in Level B PPE. Following the collection, each sample was tested through standard haz-cat procedures by a ERRS provided chemist to determine the properties of each waste and compatibility for bulking and disposal. The haz-cat test results were recorded onto a log sheet and can be found in the Site files. The haz-cat inventory includes results from; 20 containers and buckets of five gallon or less; 87 drums; 15 totes; and 14 ASTs. Waste containers were then sorted into groups of similar disposal waste streams, assessed of their condition, and if necessary, placed into over-packing drums to secure their contents.

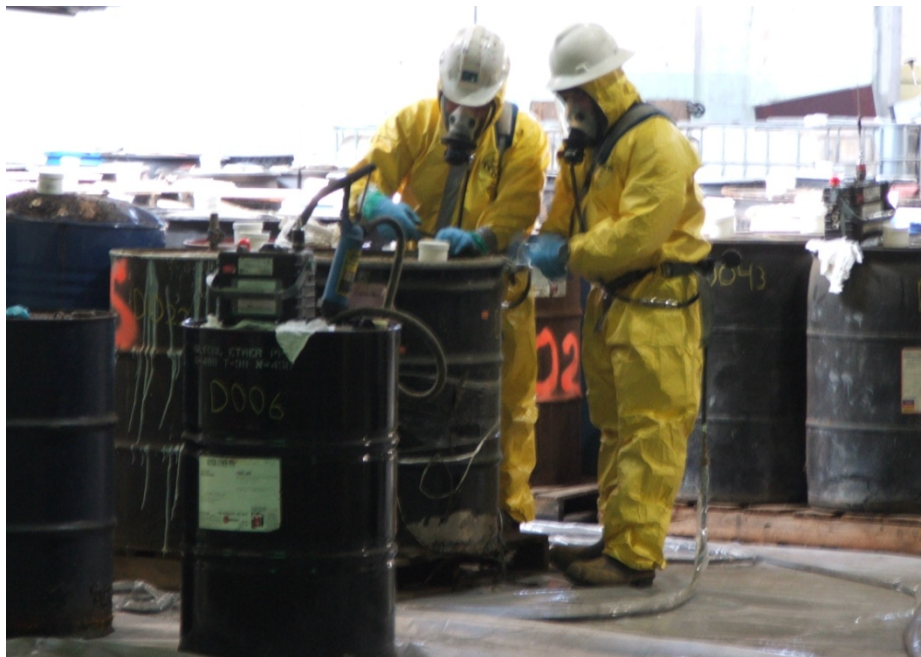
**Photograph No.:** 12

**Subject:** Level B PPE sampling

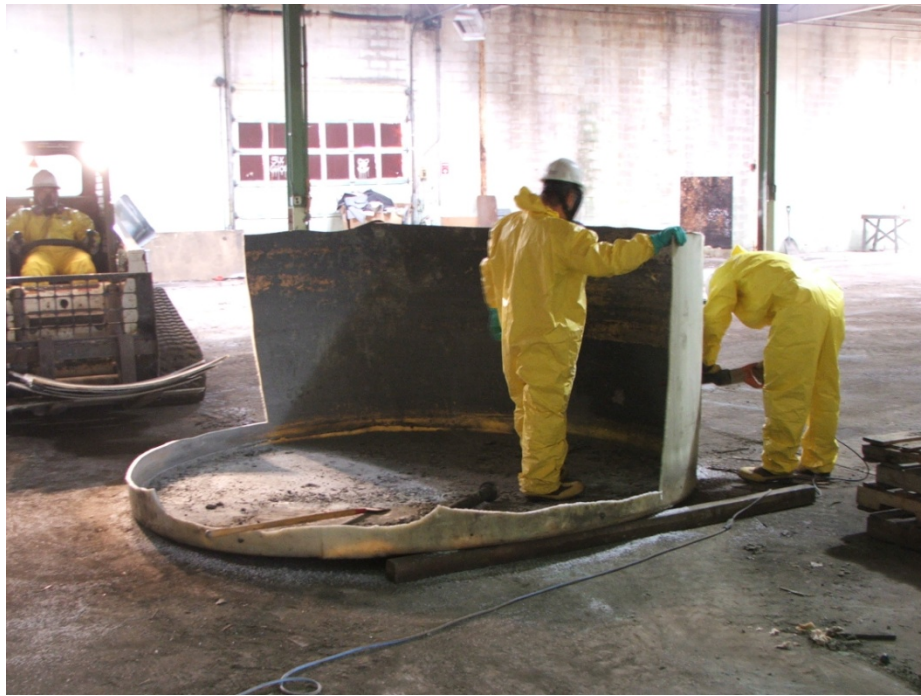
**Site:** Durable Coatings  
**Photograph No.:** 13  
**Direction:** East  
**Subject:** Cutting of ASTs, rendering them unusable

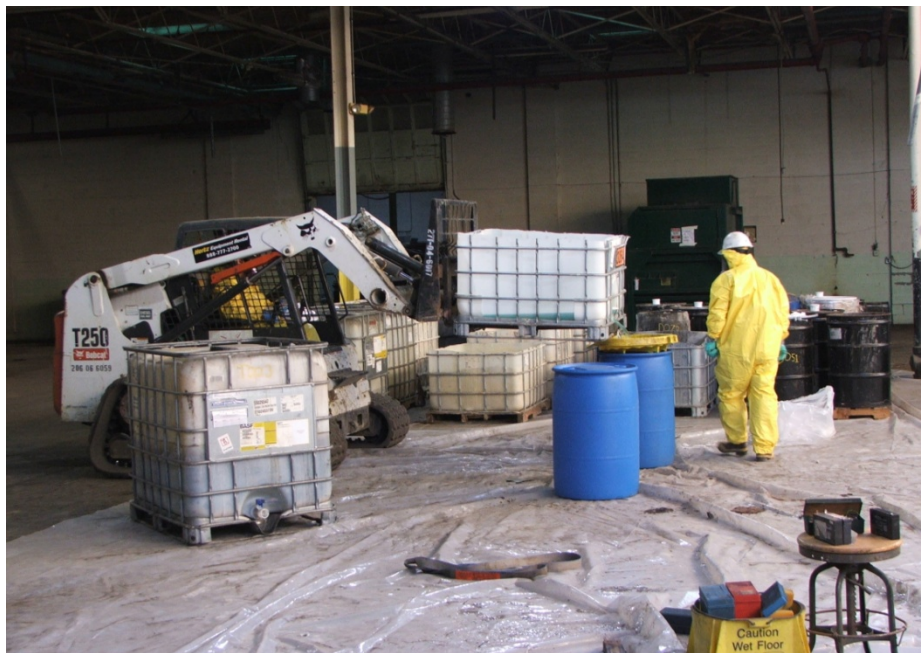
**Site:** Durable Coatings  
**Photograph No.:** 14  
**Direction:** East  
**Subject:** ERRS staging drums and totes in Room 7

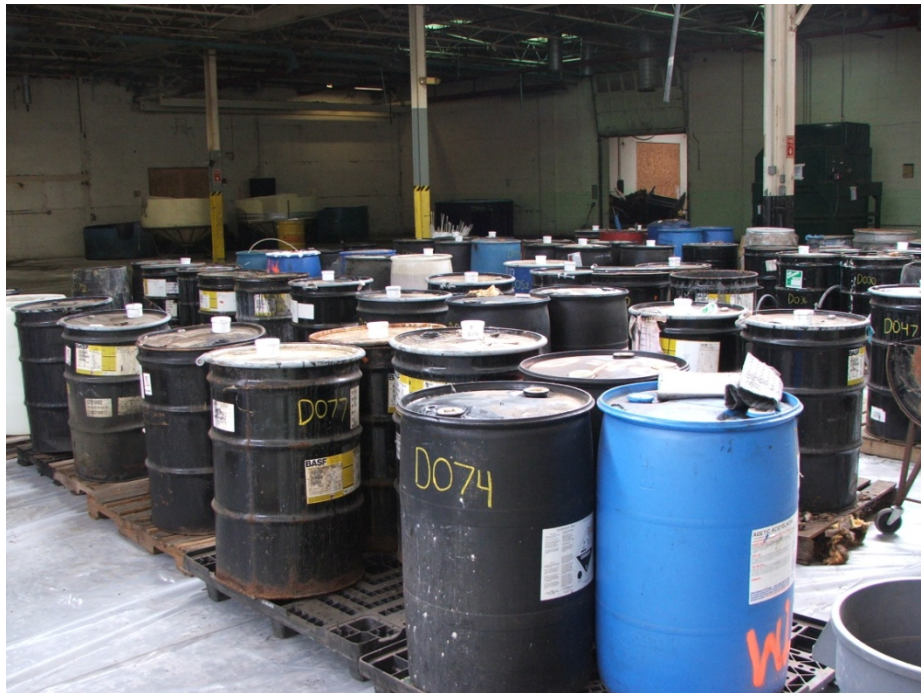
**Photograph No.:** 15

**Subject:** Staged drums after being sampled

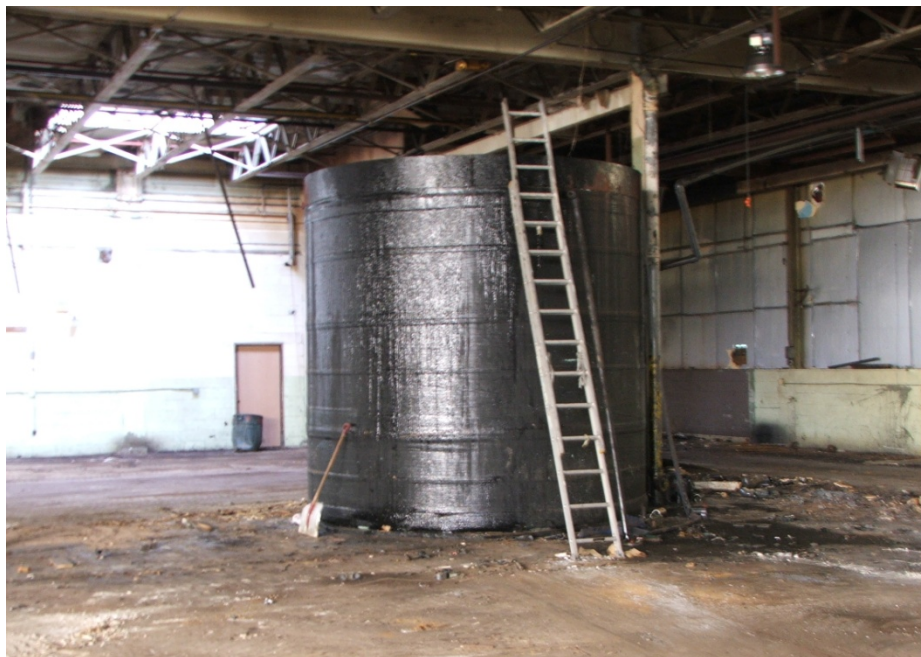
**Photograph No.:** 16

**Subject:** Large AST

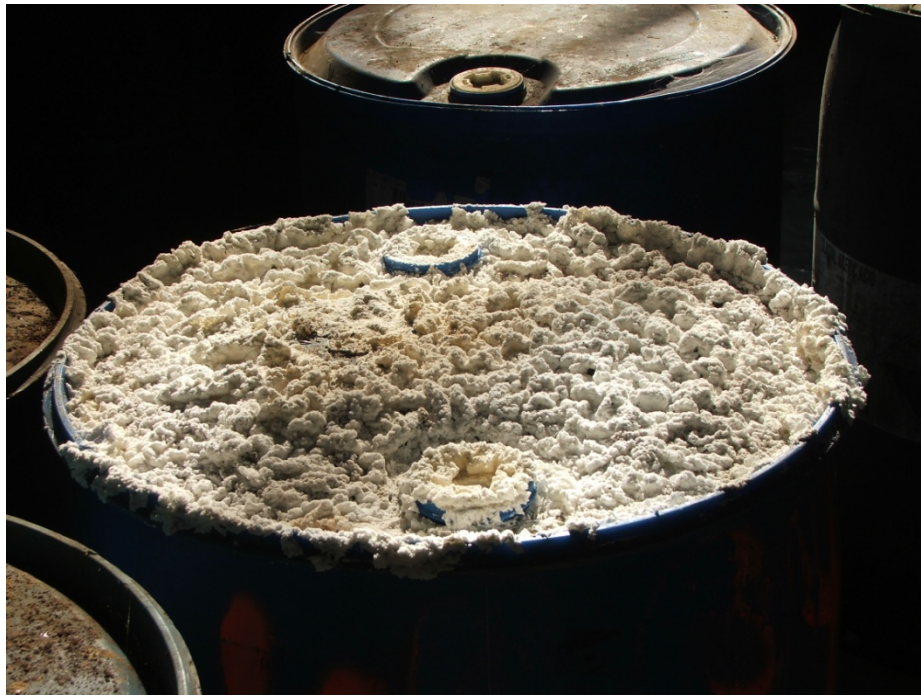
**Photograph No.:** 17

**Subject:** Sodium hydroxide crystallization

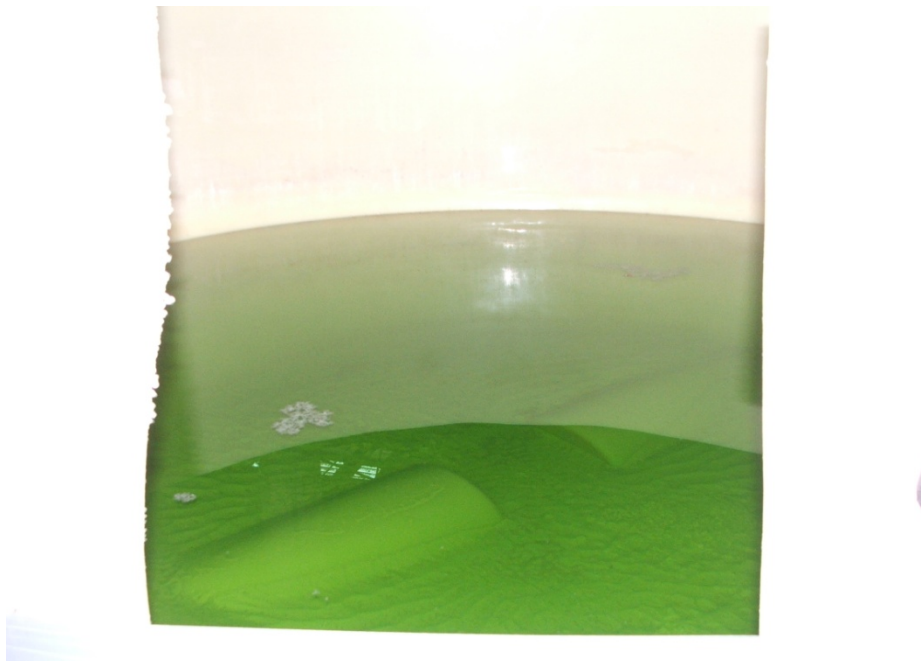
**Photograph No.:** 18

**Subject:** Cut AST with unknown green liquid inside

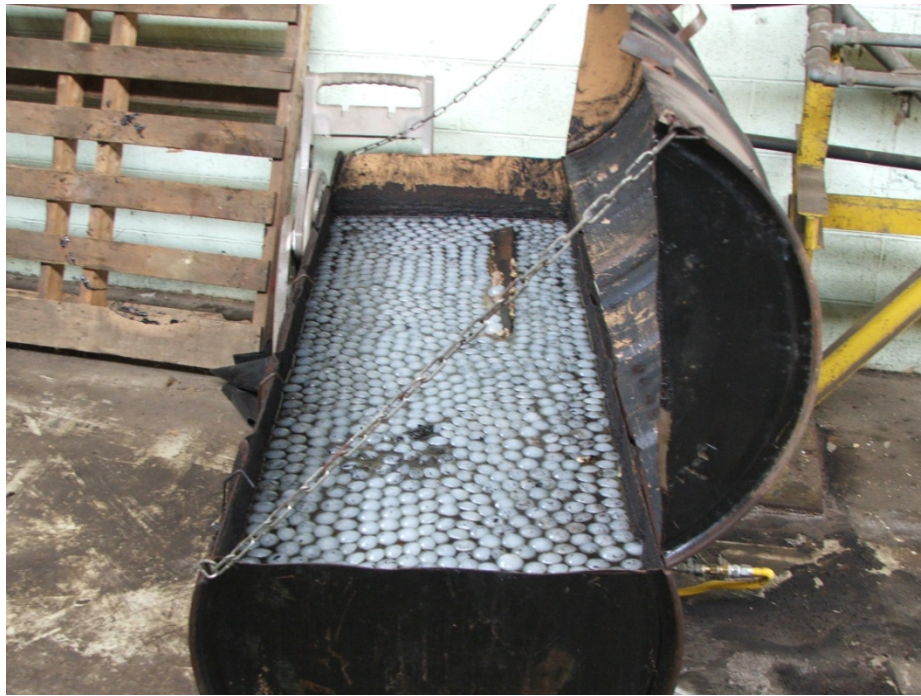
**Site:** Durable Coatings  
**Photograph No.:** 19  
**Direction:** Down  
**Subject:** Unknown waste

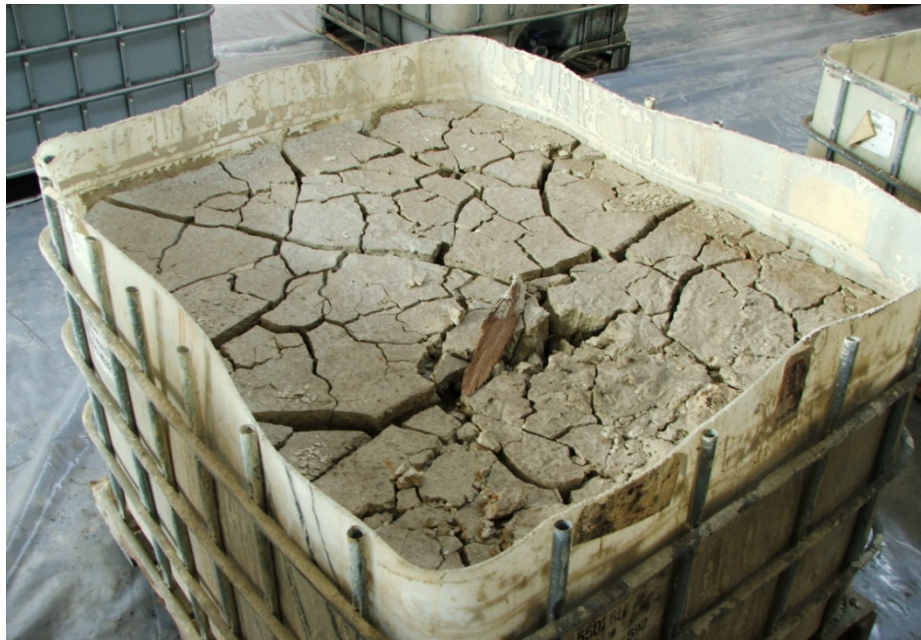
**Site:** Durable Coatings  
**Photograph No.:** 20  
**Direction:** Down  
**Subject:** Tote with unknown solids
